Vert Portant - BC050/DCM R00 - September, 2017 - Photo Credits : TMC Marine, Bureau Veritas, Pixel Thermographics Ltd

## REDUCING THE RISK OF PROPULSION LOSS

Operational guidance for preventing  
blackouts and main engine failures

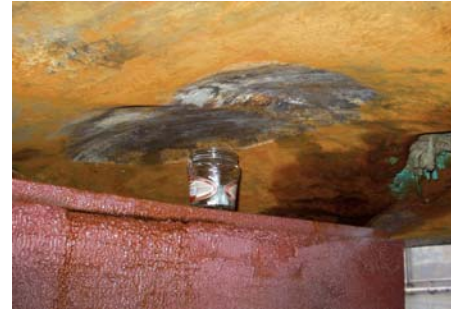
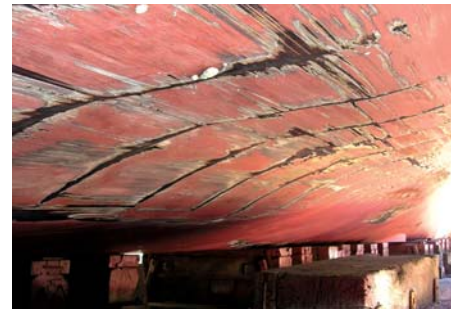
▲ Bottom damages as a consequence of machinery failures<sup>1</sup>

<sup>1</sup> On the top photo, the glass jar is here to highlight the degree to which the shell plating is set in.

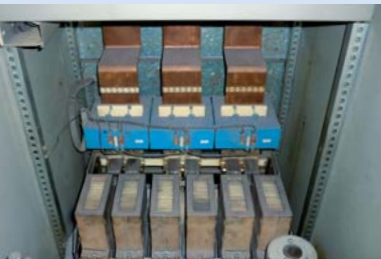
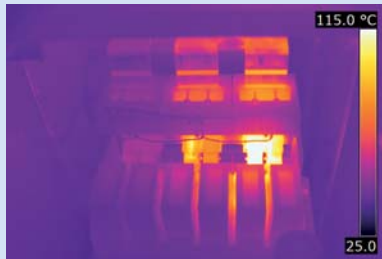
▲ Digital and thermal images of a switchboard breaker fault

- A regular thermographic survey of the switchboard should be carried out to monitor for loose connections or overheating equipment.
- The alarm printer, where fitted, should be maintained correctly, such that the printout is legible, as this is often a valuable source of information regarding the cause of the blackout.
